DELAWARE BUILDING

PRESERVATION

NUMBER 11

Installing Insulating Glass In Existing Wooden Sash Incorporating the Historic Glass

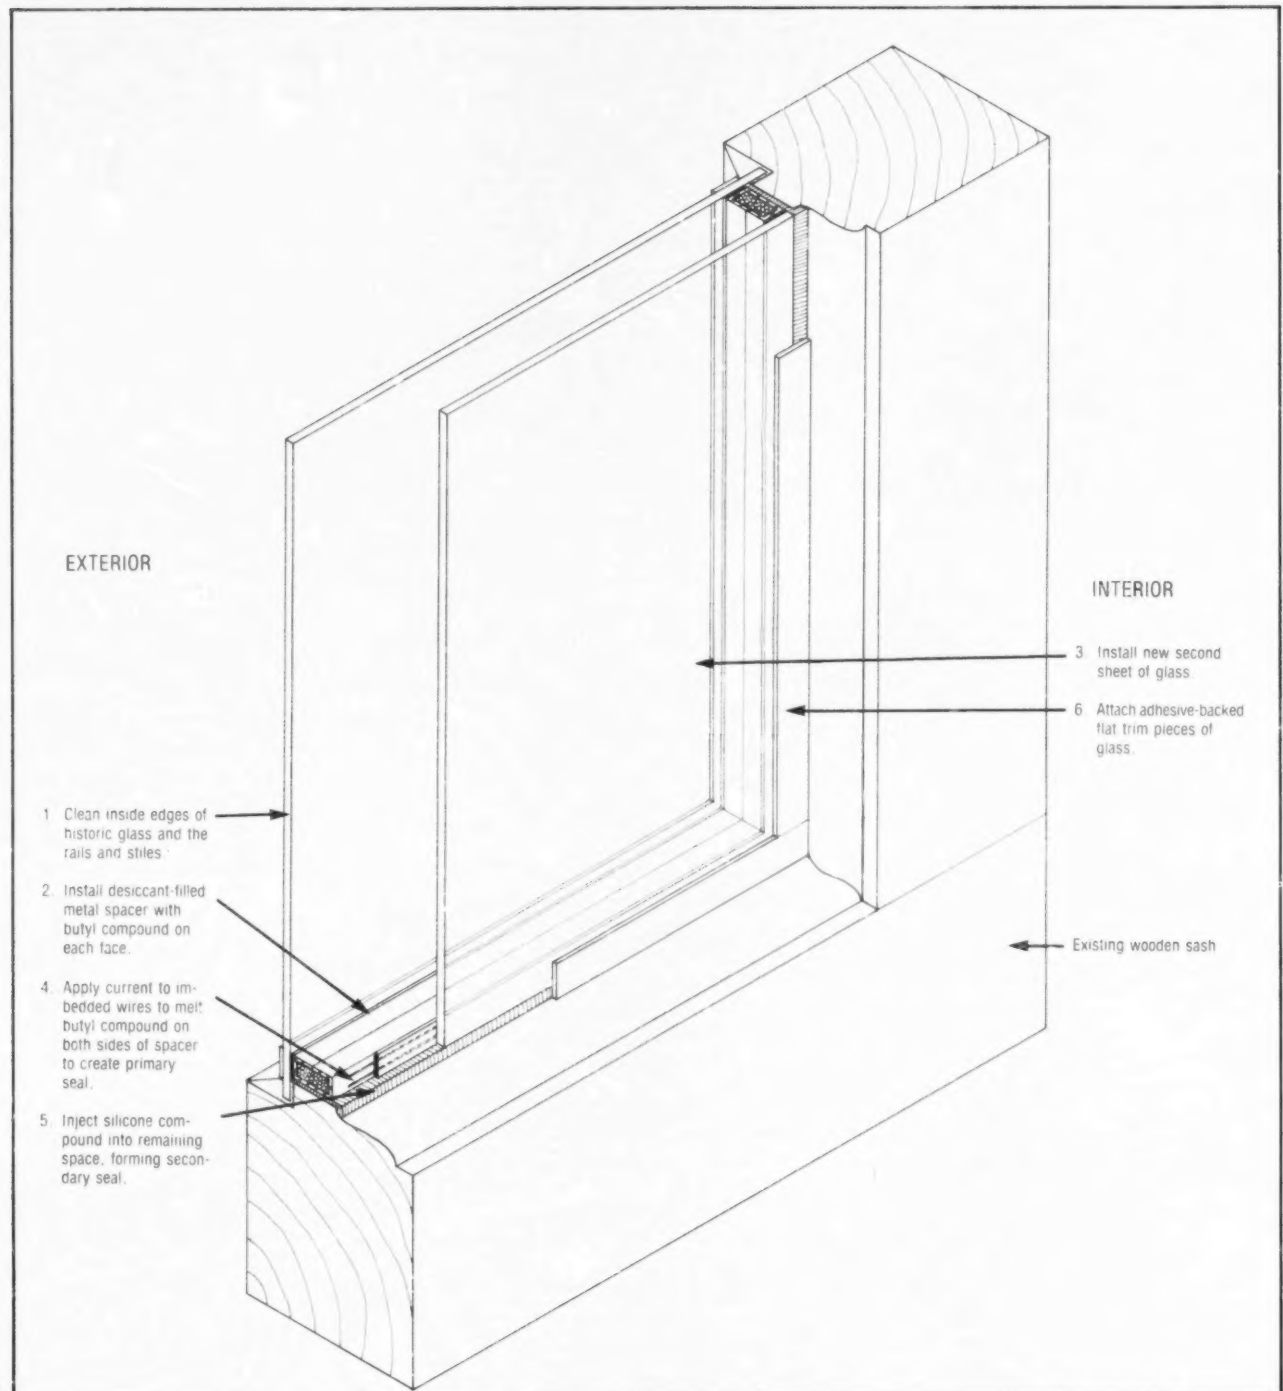
The technique used for double glazing the windows, incorporating the existing glass, was developed in Europe and in use there since the mid 1970s. This technique uses only one additional sheet of glass, placed off the inside edges of the rails and stiles, to create a sealed insulating unit. Since the metal spacer placed between the glass sheets is set slightly off the edges of the rails and stiles, the retrofitted insulating unit reduces the historic glass exposure by about 1/2" along all sides. This tends to limit the applicability of this technique for double glazing to upper floor windows with large lights since at such distances the reduction in exposed glass area is not readily visible (see figure 1). At the third floor level and

above, the 1/2" encroachment along the edges of the glass on the large sash at the Delaware Building was determined not readily visible from the street. The architect felt that the additional expense to avoid any sight encroachment was not justified for an alternate approach entailing the routing out the 2 1/4" thick sash on the inside putty rabbet to a greater depth in order to accept an all new sealed insulating unit. Such an alternative, however, might have been appropriate had the interior moldings along the inside rail and stile been more decorative, since the added

Figure 1. Since the metal spacer placed between the glass sheets is set slightly off the edges of the rails and stiles, the retrofitted insulating unit reduces the historic glass exposure by about 1/2" along all sides. This change on large windows is hardly noticeable particularly once the flat trim piece is glued in place. Photo: Charles E. Fisher.
